## Oil Technics: Biological Cleaning Trial

This strategy cleaning was tested at a busy five-island Petrol Station in the Netherlands. The operator had oil discharges averaging 500ppm and wanted to see these discharges reduced to meet European Standard 858:

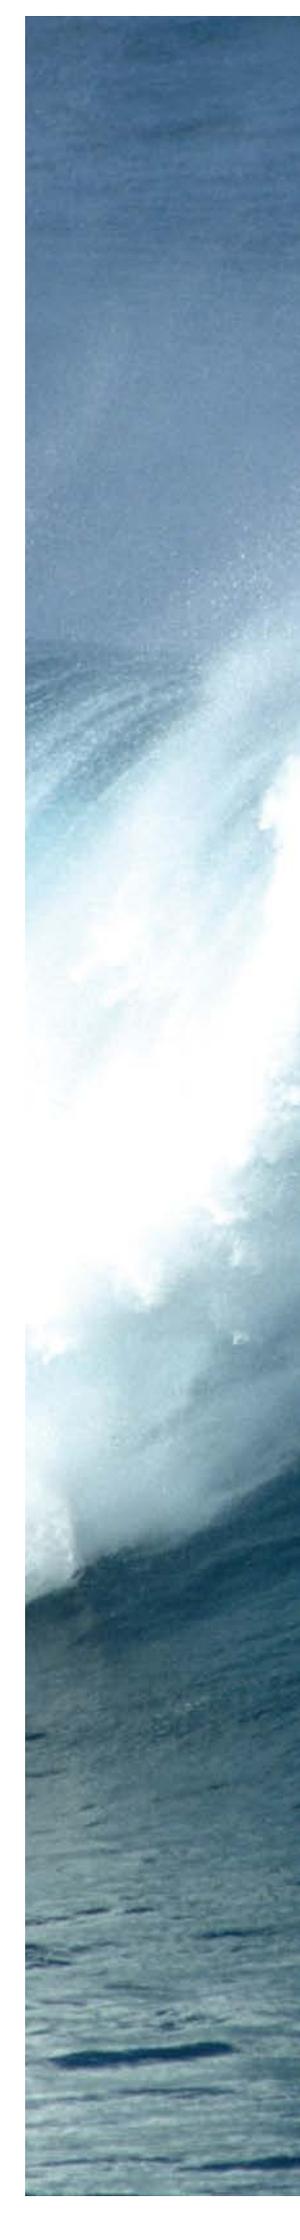
Month 1	Month 3	Month 5	Month 7
<b>1. Water sample pH</b>	<b>4.9</b>	<b>2.6</b>	<b>6.6</b>	<b>6.7</b>
<b>2. Oxygen Demand</b>				
i. BOD mg/litre	290	7950	225	165
ii. COD mg/litre	477	250	662	258
iii. BOD/COD	<b>0.61</b>	<b>31.8</b>	<b>0.34</b>	<b>0.64</b>
<b>3. Mineral oil fraction mg/litre</b>				
i. C10 – C12	38.00	390.00	3.90	0.85
ii. C12 – C14	99.00	570.00	5.80	0.84
iii. C14 – c20	250.00	1500.00	36.00	8.60
iv. C20 – C26	110.00	710.00	34.00	6.80
v. C26 – C34	17.00	110.00	2.90	1.80
vi. C34 – C40	0.02	12.00	2.20	0.16
<b>4. Total oil C10 – C40</b>	<b>514.02</b>	<b>3292.00</b>	<b>84.80</b>	<b>19.05</b>
<b>5. Target mg/litre</b>	<20.00	<20.00	<20.00	<20.00

The results showed a dramatic reduction from Month 3 to Month 7 across the carbon chain (see above table).

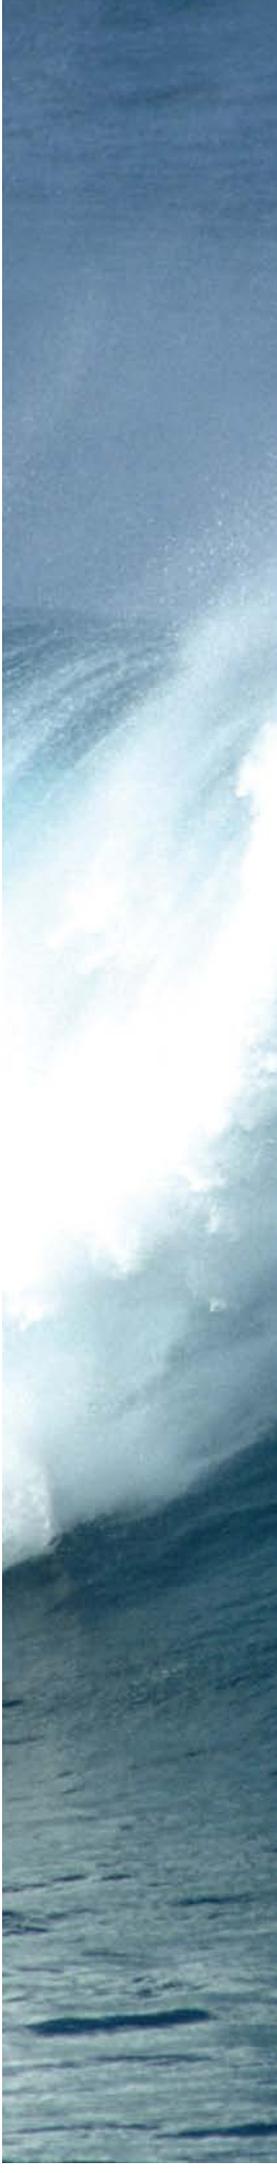
In Month 1 effluent oil discharges were 514 mg/litre.

In Month 3, following the total site clean up using OT8, oil discharges were 3292 mg/litre!

By Month 7, this was reduced to 19 mg/litre using the combination of Bio Tubes within the separator and the continued use of Forecourt Bio.

By Month 7, these discharges had been reduced from 3292 to 19 mg/litre - **a reduction of 95%**.
